**Macrolux**[®]

CORRUGATED POLYCARBONATE SHEET PRODUCT

10 YEAR NON PRORATED WARRANTY

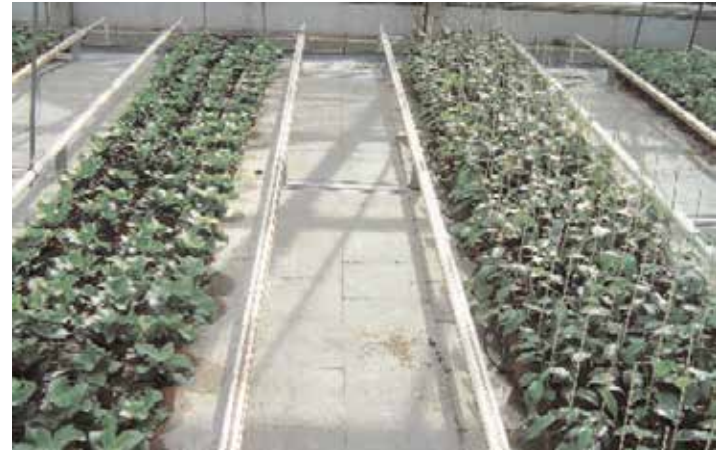
Shadows with clear covering

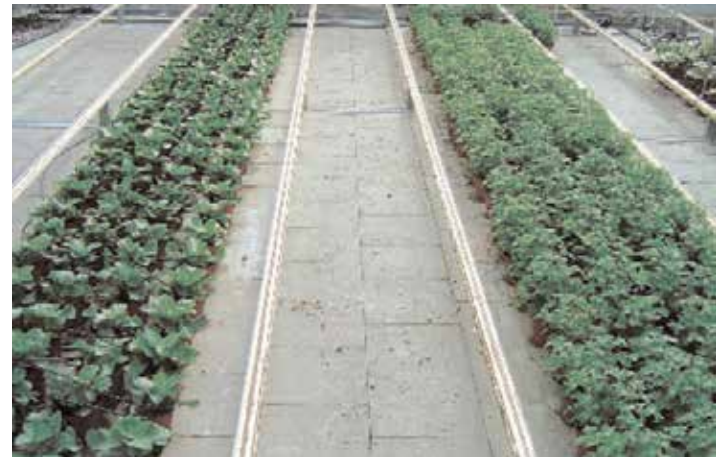
No shadows with HD Soft White
